25th International Conference on Fracture and Structural Integrity

# Optimizing strengthening interventions on historic masonry walls: an experimental study

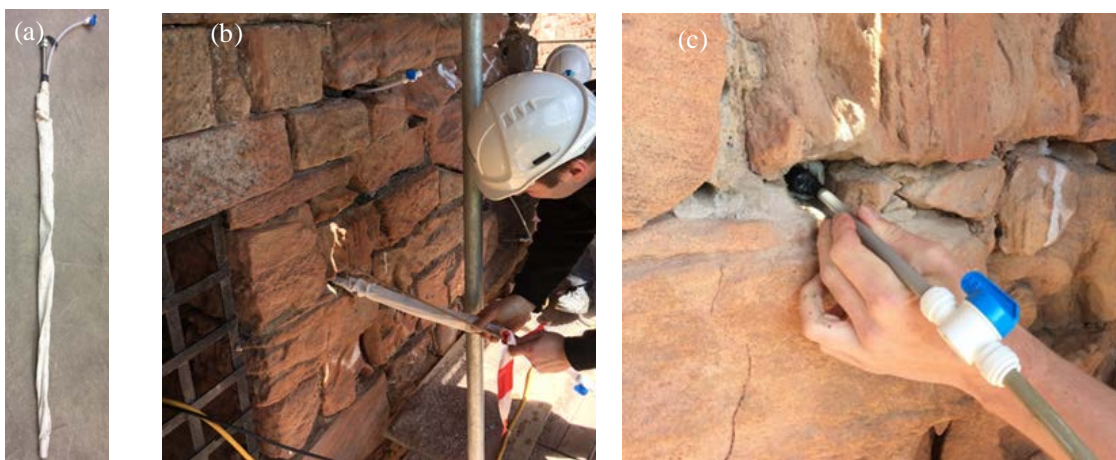
Fig. 2. (a) Cintec™ anchoring system; (b) installation of anchoring system and (c) injection of cementitious grout in the fabric sleeve, at the Latrine Tower, Bothwell castle.

In the above context, the strengthening technique implemented at Bothwell castle relies on indenting and the installation of a reinforcement and anchoring system by Cintec™ (Fig. 2a). Indenting of decayed stones which are structurally defective and introducing stainless steel helical bars into bed joints provide bearing and support for facing masonry from the base up and also tie the structure back together again, curtailing the tendency to spread and crack (Historic Environment Scotland 2016). After drilling a hole at an appropriate location into a joint, the system works by introducing there a helical bar enclosed in a mesh fabric sleeve into which a specially developed cementitious grout is later injected under low pressure (Fig. 2). The flexible sleeve loosely surrounds the helical bar and expands to fill the cavity as the grout is injected. During this process, it shapes itself into the hole and a mechanical bond is created between the elements (Cintec™ 2018).

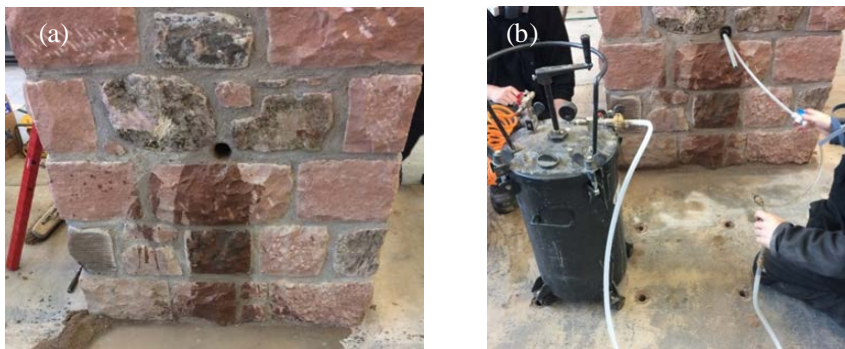
Fig. 4. Wall specimen preparation at ENU structural laboratory: (a) cleaning the hole in preparation of the anchoring system's installation; (b) injection of the cementitious grout in the fabric sleeve.

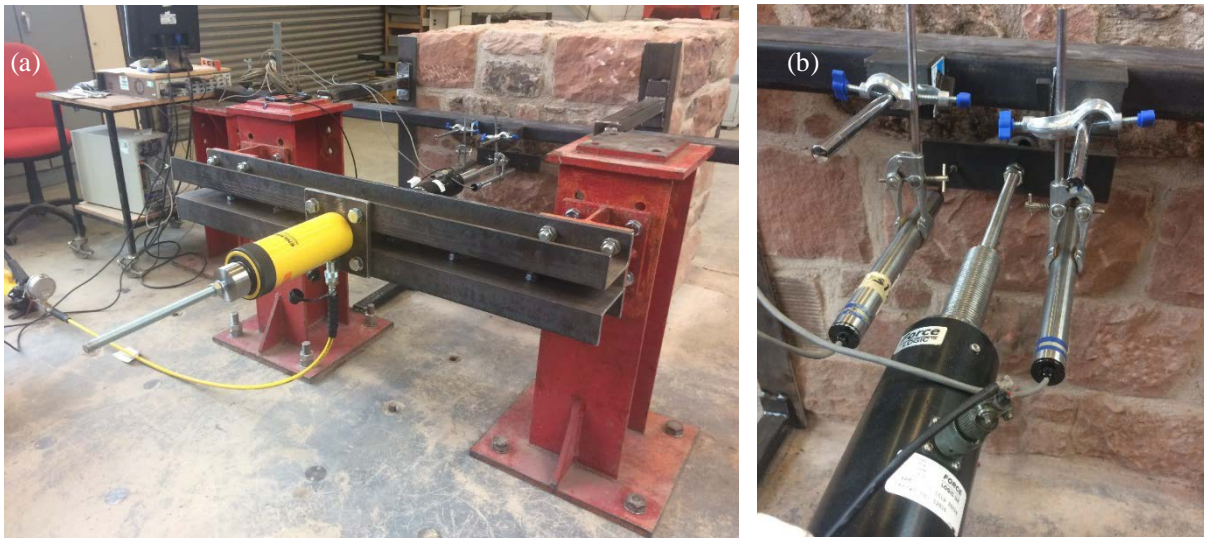
Fig. 5. (a) Overview of the experimental configuration for the pull-out test; (b) detail of the measuring equipment for anchor displacement (LVDTs).

A steel frame was appropriately designed to secure the wall specimen in position as well as support the testing equipment, which involved an ENERPAC RCH-306 hydraulic cylinder, a load cell and linear variable differential transformers (LVDT) (Fig. 5a). The test was conducted under a load control mode, with the pull-out load being applied in steps of approx. 5kN/min through the hydraulic cylinder connected to a manual pump. Two LVDTs over a gage length of 50mm were placed horizontally to measure the displacement of the anchor, mounted on a purpose made plate positioned as close as possible to the wall specimen (Fig. 5b). Such a test is considered complete when either failure occurs in the parent material (wall specimen) or when a specific displacement is reached, reasonably specified at 10mm (Paganoni and D'Ayala 2014, Paganoni 2015).

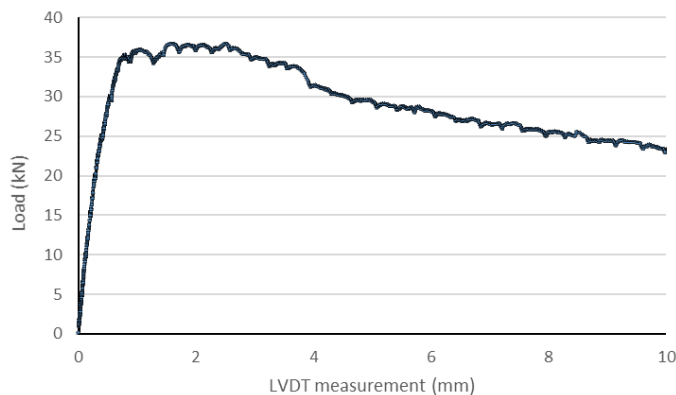
Fig. 7. Load vs. Displacement (anchor slip) curve for the pull-out test performed.

The overall pull-out behaviour of the anchor is illustrated in Fig. 7, in terms of force exerted (load in kN) versus average LVDT measurements (slip in mm). Results are presented here up to a meaningful slip of 10mm, which corresponds to approx. 60% of the total load carrying capacity of the anchor. The maximum load achieved was 36.68kN, at a point of anchor slip equal to 1.62mm. It is worth noting that for load levels around 35 kN and slip approx. 1mm, it became evident that it was hard to increase the load sustained, which remained relatively stable for a range of slip measurements between 1mm and 3mm. After the attainment of the maximum load within a period of small load fluctuations as described above, during which the anchor kept its capacity due to friction and mechanical interlocking, the load continued dropping while LVDT measurements increased, until the point of complete failure by pull-out.

The bearing capacity of the anchor is dependent on the geometry and characteristics of the grouted fabric sleeve, as any failure mode not directly involving failure of the threaded bar would rely on the compressive strength of the cementitious grout. If the grout around the threaded bar crushes and sliding begins, friction becomes the main mechanism that controls the behaviour of the anchor. Furthermore, although the threads of the steel bar are symmetrical in shape and spacing, it is not the same for the grouted fabric sleeve which fills the random voids within the masonry wall (Paganoni 2015). This means that sliding can be activated before mechanical interlocking and it is generally difficult to evaluate the bearing mechanism of the anchor as the presence of voids in the masonry and the degree of cementitious grout penetration is unknown (Paganoni 2015). In terms of interpretation of the results, it is therefore reasonable to consider a maximum load level for all practical purposes (at 35 kN for this case), instead of an absolute maximum load value.
