# Investigations of Physical and Chemical Characteristics of Masonry Stones and Bricks during Building Cleaning: Part 1. Physical Testing

**Abstract:** This series of study focused on analysing and assessing the changes of the physical and chemical characteristics of the surfaces of the masonry stones and bricks during the sandblasting cleaning process by conducting various physical and chemical tests. Seven masonry stones and bricks were adopted, including yellow sandstone, red sandstone, limestone, marble, granite, white clay brick and yellow clay brick. The physical testing included evaluating the cleaning degree, determining the Vickers hardness, and detecting the water absorption. Using a digital imaging analysis method, the greyscale and cleanness were introduced to quantitatively assess the effectiveness of masonry building cleaning and confirmed to be useful and appropriate. The cleanness analysis, together with the hardness and water absorption tests showed that a masonry stone or a brick with a higher cleaning degree corresponded to a brighter and harder stone surface. In general, the physical properties were found to vary largely during the building cleaning.

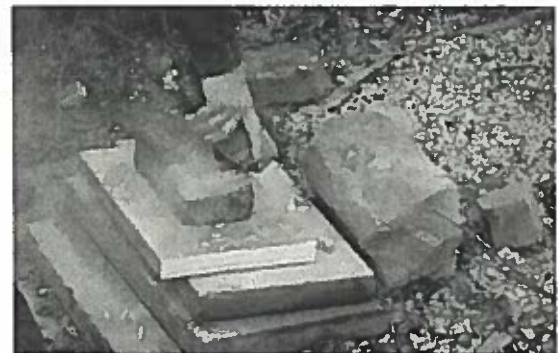
Fig. 1 Samples cut from masonry stones and bricks using a diamond saw.

Masonry stones and bricks were selected from those for the 1860s-1870s listed buildings in the south west of the city of Edinburgh, which were popularly used for local buildings [30] and exposed to the open environmental conditions for more than a century with large amounts of heavy soiling on the surfaces. A diamond saw was used to cut the masonry stones and bricks into small samples (Fig. 1). The exposed surfaces of the stones and bricks were cleaned into different levels using the abrasive sandblasting cleaning, and then they were cut into the required sizes for various physical and chemical tests. Here the abrasive cleaning system selected included an air compressor, a shot blasting cabinet and a blasting gun inside the cabinet (Fig. 2).

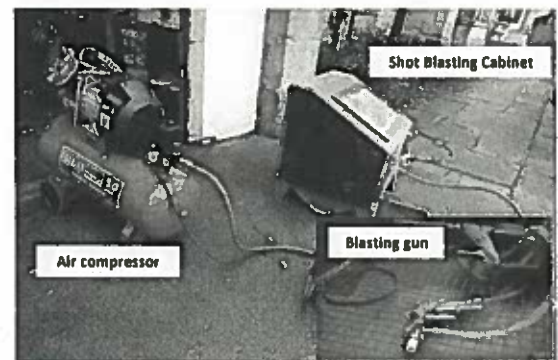
Fig. 2 The abrasive cleaning system.

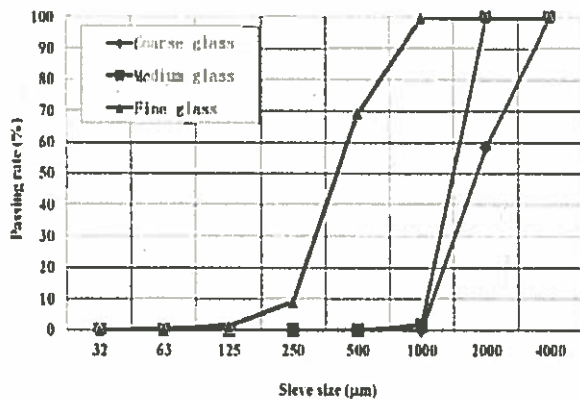
Fig. 4 Passing rates of glass particles.

measured as 6.41, 5.98 and 4.20 for coarse, medium and fine glass particles, respectively [31]. Fig. 4 shows particle size distributions of the glass particles, which indicates that the difference in fineness between the coarse and medium glass particles was small. Preliminary tests were conducted on all three types of glass particles and fine glass was found to be the most effective abrasive material for building cleaning. In this study, the fine glass particles were hence adopted for cleaning the masonry stones and bricks.

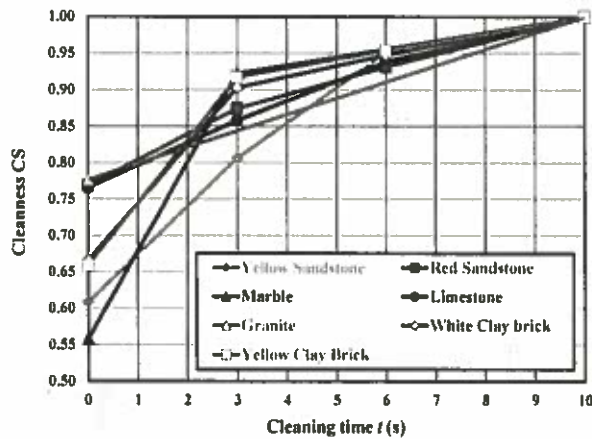
Fig. 21 Greyscale versus cleaning time for various masonry stones and bricks.

Fig. 21 illustrates the relationships between the greyscale and cleaning time for all seven types of masonry stones and bricks.

In general, the greyscale gradually increased with the cleaning time but at a decrease rate and tended to be stable when the surface was fully cleaned. These trends can be expressed by a parabolic or bi-linear relationship. The differences in the greyscale between the original dirty and fully cleaned surfaces can be used to assess the dirty conditions on the stone or brick surface. The larger the difference in greyscale, the dirtier the original stone surface. Marble had a largest difference of 68.26 so its original surface was the dirtiest. The differences in greyscale for yellow clay brick, white clay brick, yellow sandstone and limestone varied from 47.93 to 38.29 so they were relatively dirtier. The greyscale differences for granite and red sandstone were only 33.23 and 21.22, respectively, which indicates that the original red sandstone was the least dirty.

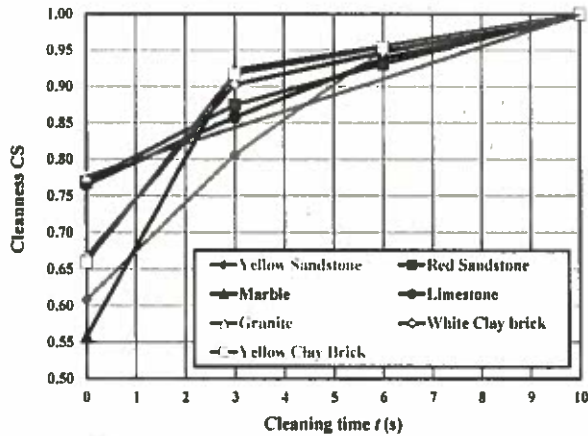
**Fig. 22** Cleanness versus cleaning time for various masonry stones and bricks.

and Fig. 22 illustrates the corresponding relationships between the cleanness and cleaning time. It can be seen that the cleanness had the same increasing trends with the cleaning time as the greyscale. The smaller the value of the cleanness, the dirtier the original dirty stone surface. The cleanness value for dirty surfaces varied between 0.56 for marble and 0.78 for granite. It is obvious that the original surface of marble was the dirtiest, followed by yellow sandstone, yellow clay brick and white clay brick. Granite, red sandstone and limestone had the least dirty original surfaces. These trends generally match those with respect to the greyscale, which indicates that the digital imaging analysis and the two proposed parameters can be used for quantitatively assessing the cleaning degree.

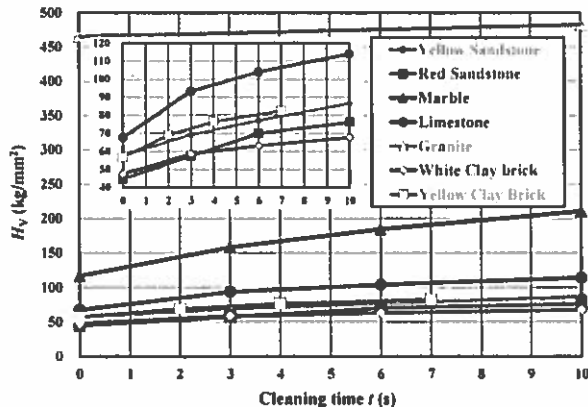
Fig. 26 Vickers hardness number versus cleaning time for various masonry stones and bricks.

Fig. 26 illustrates the Vickers hardness number against the cleaning time for all seven types of stones and bricks. A small figure is also inserted in Fig. 26 to give a clearer view of the trends for five stones with lower Vickers hardness numbers. In general, the Vickers hardness number for all stones and bricks

gradually increased with the increasing cleaning time but at a decrease rate. These trends can be well expressed using parabolic relationships with high correlations.

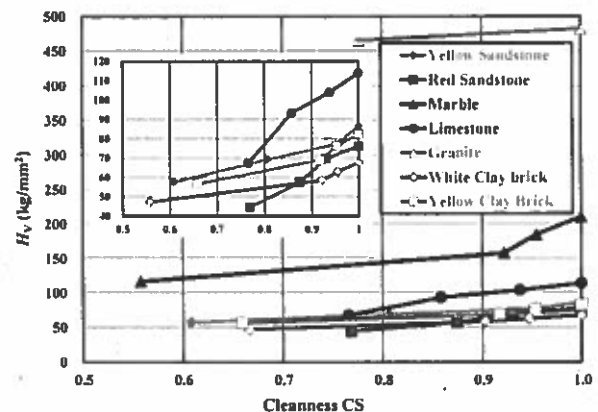
Fig. 27 Vickers hardness number versus cleanness for various masonry stones and bricks.

Fig. 27 illustrates the Vickers hardness number against the cleanness for all stones and bricks. A small figure is inserted to help view more closely the trends for five masonry stones and bricks with lower Vickers hardness. In general, the Vickers hardness number for all stones and bricks monotonically increased with the increasing cleanness, and these trends can be expressed using linear or bilinear relationships. It is obvious that the original granite had the hardest and cleanest surface while the surface of the original marble was harder than any other stones except granite and was extremely dirty.

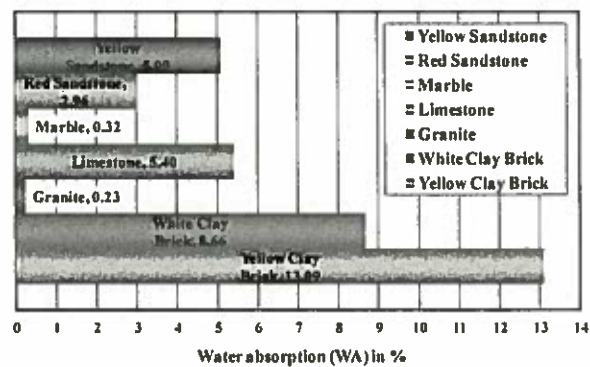
Fig. 29 Water absorption for various types of masonry stones and bricks.

Fig. 29 illustrates the measured values of the water absorption for all seven types of stones and bricks. Yellow and white clay bricks had the largest water absorptions among all the samples, with WA = 3.09% and 8.66%, respectively. Limestone, yellow sandstone and red sandstone also had relatively high water absorptions, with WA = 5.40%, 5.09% and 2.96%, respectively. On contrast, marble and granite absorbed little water so as to have the lowest water absorptions, with WA = 0.32% and 0.23%.

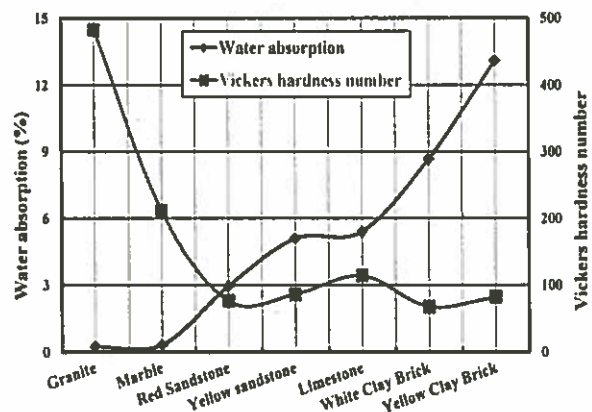
Fig. 30 Comparison between the water absorption and the Vickers hardness number for various types of masonry stones and bricks.

Fig. 30 shows the comparison between the water absorption and the Vickers hardness number for various types of stones and bricks. Two opposite trends can be clearly observed: the hardness approximately decreased while the corresponding water absorption continually increased. The water absorption of granite which had a hardest surface was the lowest. Similarly, yellow clay brick which was extremely soft had the highest water absorption. In general, greater water absorption likely corresponded to a softer stone or brick, while lower water absorption corresponded to a harder stone or brick.
